Remanufactured  
**Allison Transmission**  
Teardown/Competitive Analysis

# TRC vs. The Competition

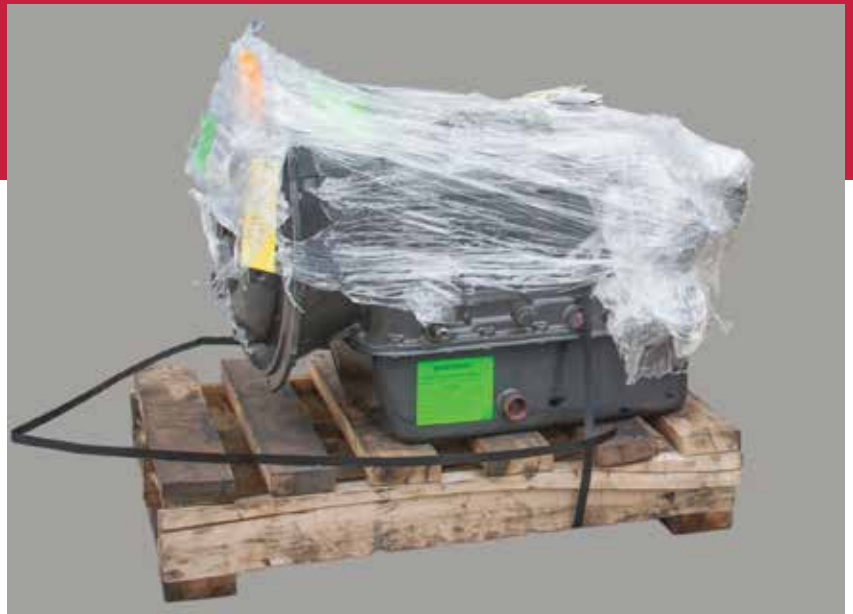
The competitor's transmission is strapped to a standard shipping pallet. One of the straps is broken, allowing the unit to move extensively during transit.

Competitor's transmission is sitting directly on the pallet with the oil pan and the filter bearing the full weight of the unit.

The pallet is oil-soaked and broken. The cling-film wrap barely remains intact which offers minimal protection during storage and shipment.

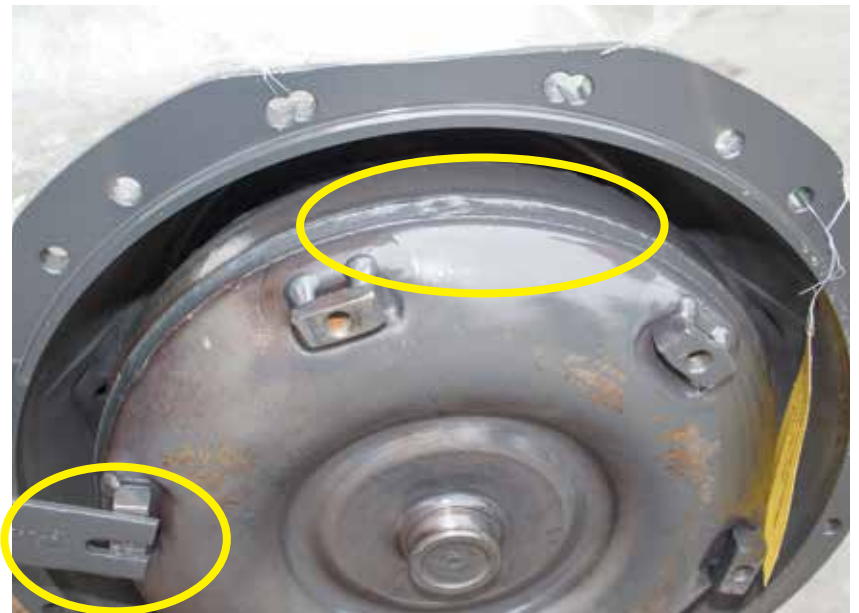
The competitor is using a refurbished torque converter (see the heavy weld seam around the perimeter and wear marks). This is not allowed by Allison.

Given the high instances of failures with refurbished torque converters, the specification is for only new converters on every unit.

Also note the lock retainer is not secured. This will allow excessive movement during transit and cause wear on internal parts and seals.

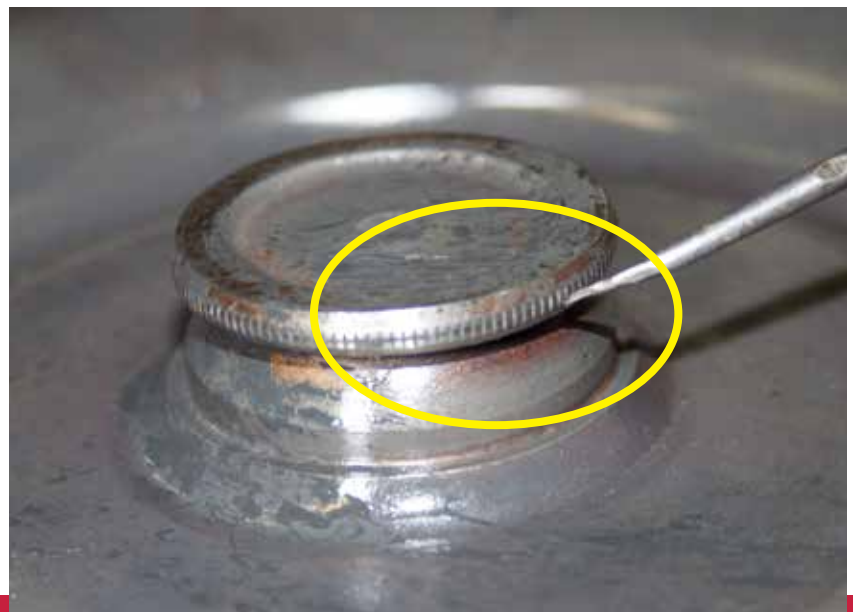
Signs of visible wear and distortion on the competitor's torque converter's knurled edges which can cause adaptation issues and premature failure.

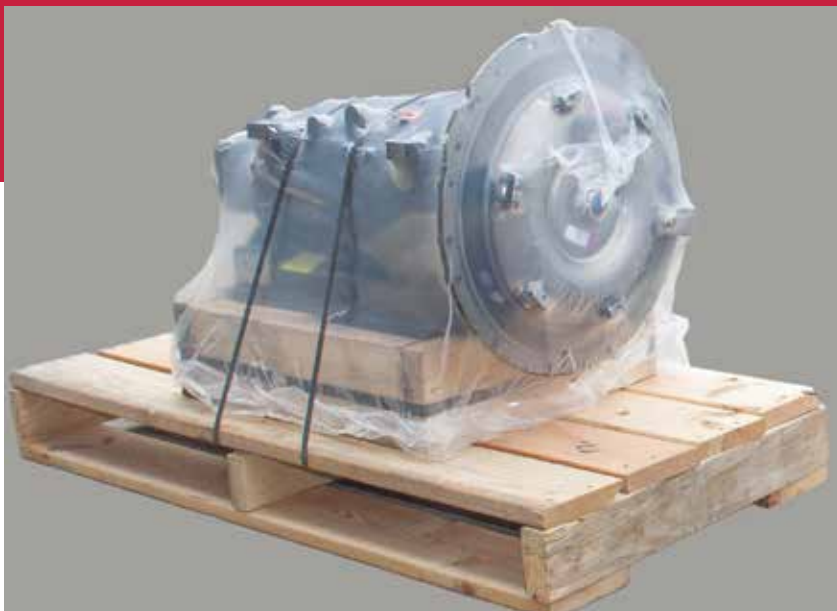
Our transmissions use specially-designed pallets to protect the transmission. Note that no weight is borne by the oil pan.

We also use 7 mil shrink wrap and standardized straps to ensure no damage during shipment.

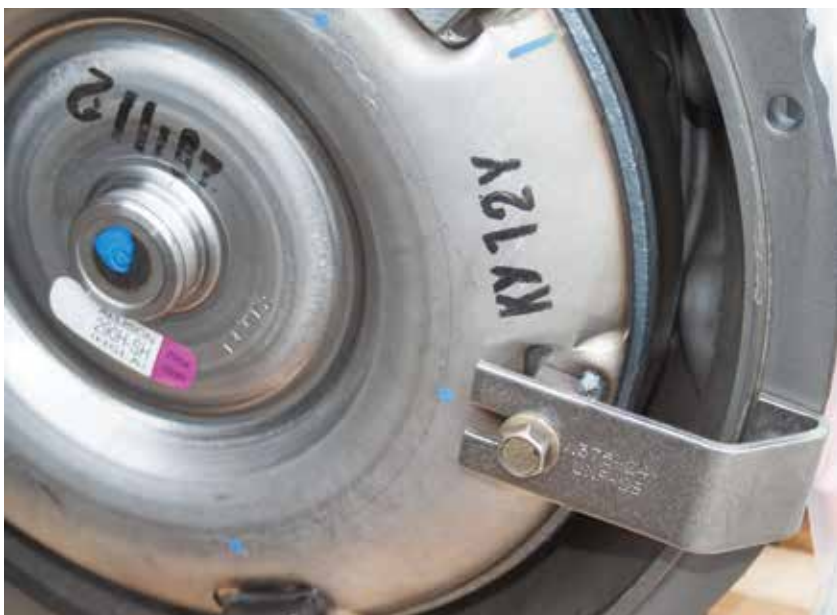
The TRC torque converter is brand-new, per Allison spec. Also note that the transport retainer is properly installed.

Historically, we have seen up to 50% of failures to be in the torque converter, so new is the only logical choice, even if the initial cost is slightly more.

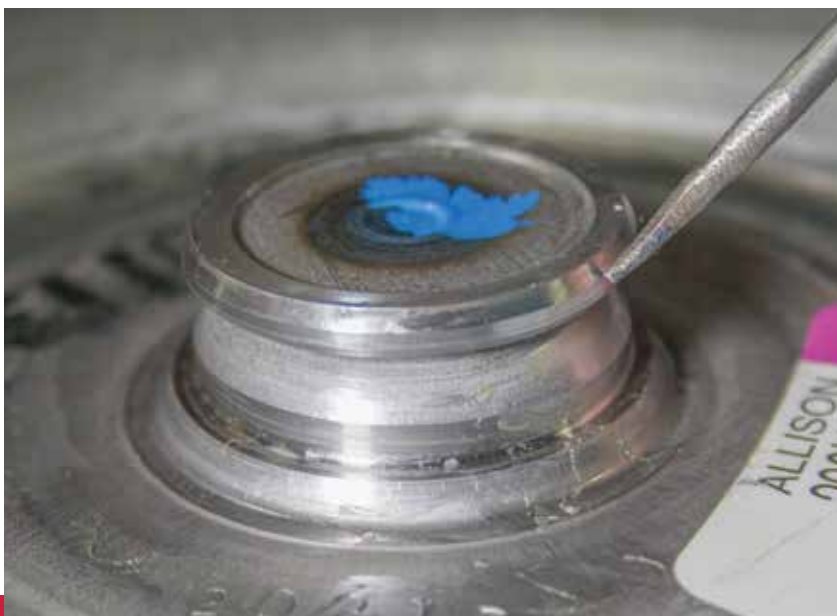
The knurled edges of a new torque converter are clearly in better condition for longer life.

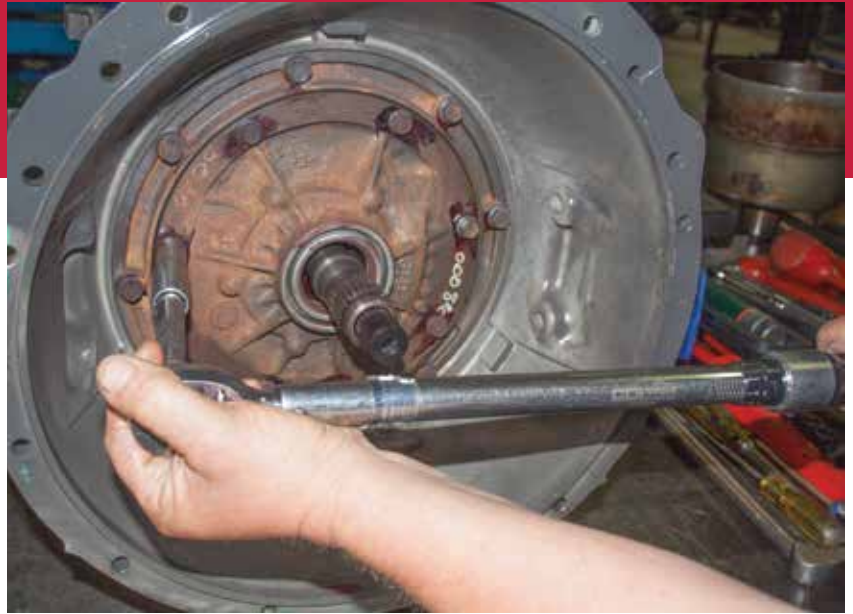
Inspection confirms that torque on their bolts varied from 10-12 ft/lbs.

The Allison spec call for torque between 18-24 ft./lbs. Improperly torqued bolts can lead to vibration based failures and leaks.

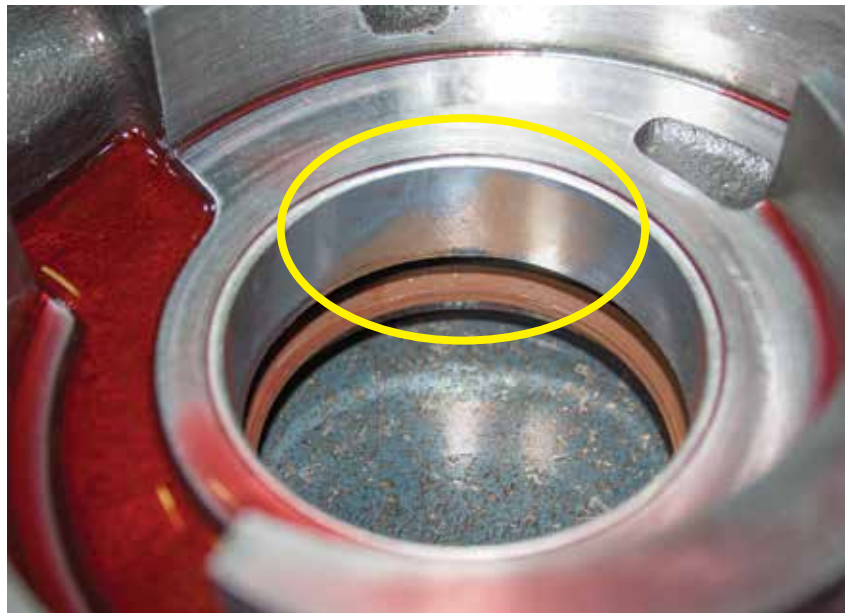
Their pump bushing is in poor shape with the bronze base metal showing through. This component should not have been salvaged.

Our transmissions always replace pump bushings with Genuine Allison new parts. Excessive clearance can lead to premature pump wear and low main pressure.

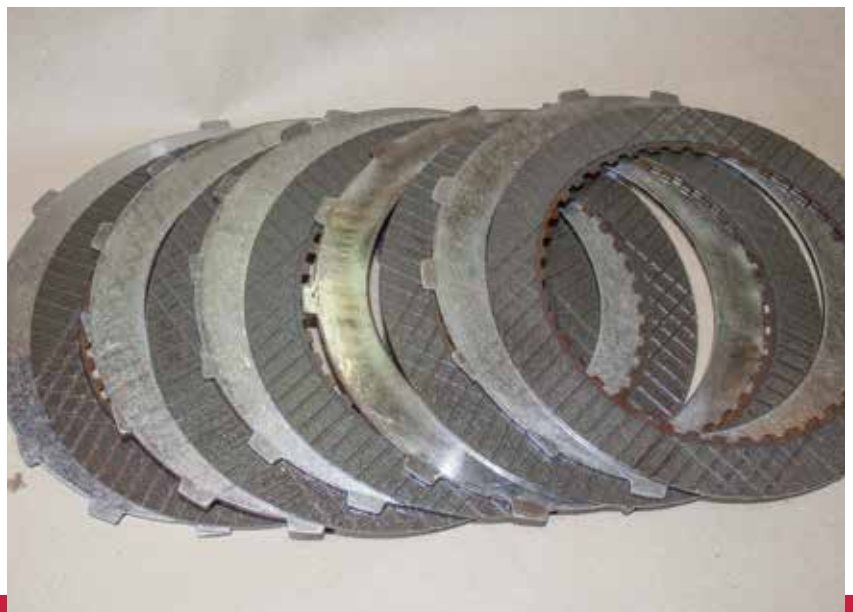
Their forward clutch and friction plates have visible burn marks, scoring and wear.

These wear components have been salvaged and re-used.

We 100% replace friction plates in the forward clutch with Genuine Allison parts, given the high application pressures.

Slipping or worn plates will lead to premature clutch failure.

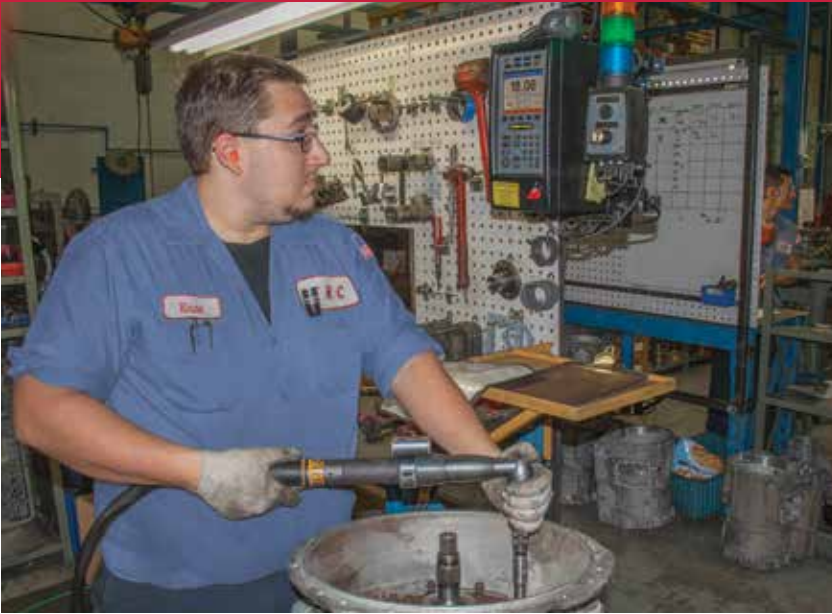
Our remanufacturing process incorporates state-of-the-art torque tools to ensure consistent torque values. Our torque station not only electronically sets appropriate torque values, but also tracks all bolts so that none are missed during the process.

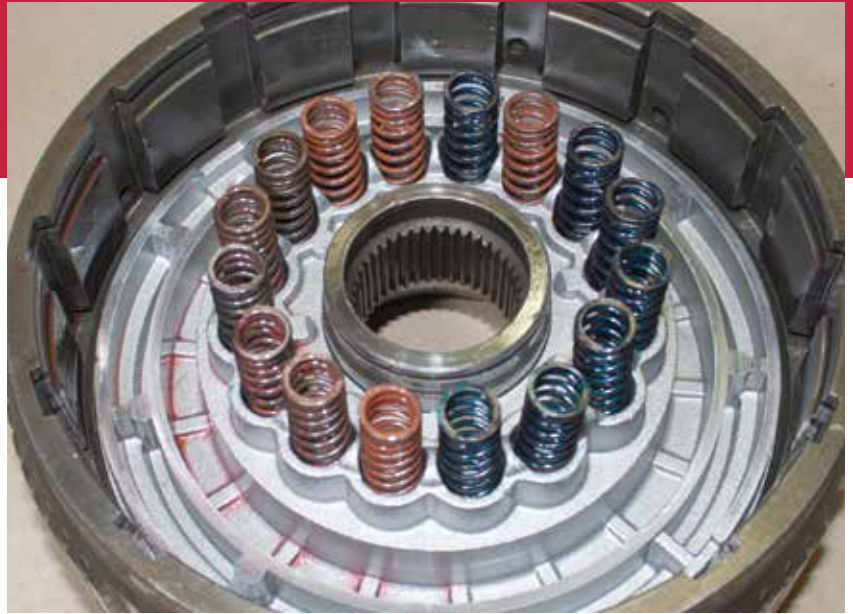
Their fourth piston spring assembly is an obvious job of mismatched spring components.

Allison designates various spring tensions by color. This application specifies all "red" springs.

Mixing springs of various tension will lead to performance issues, premature wear and eventual component failure.

Our fourth piston spring assembly utilizes the approved springs/tension to ensure proper application.

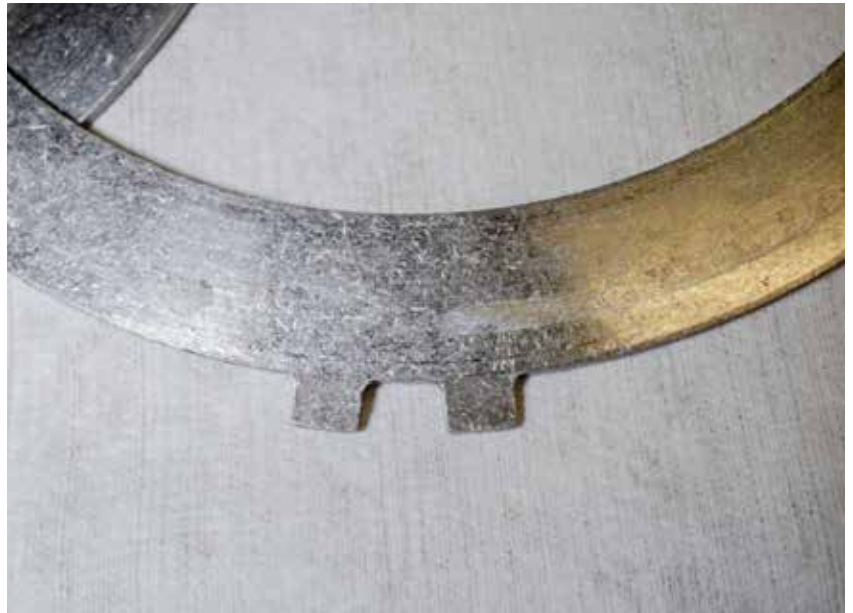
Used clutch plates in their unit are not Genuine Allison and show signs of previous wear.

Clutch plates in our units are all genuine Allison OEM parts as shown by their logo stamped on the ear.

You can also see the obvious difference in quality between genuine OE equipment and used/aftermarket parts. Sub-par used and replacement parts can lead to premature failure.

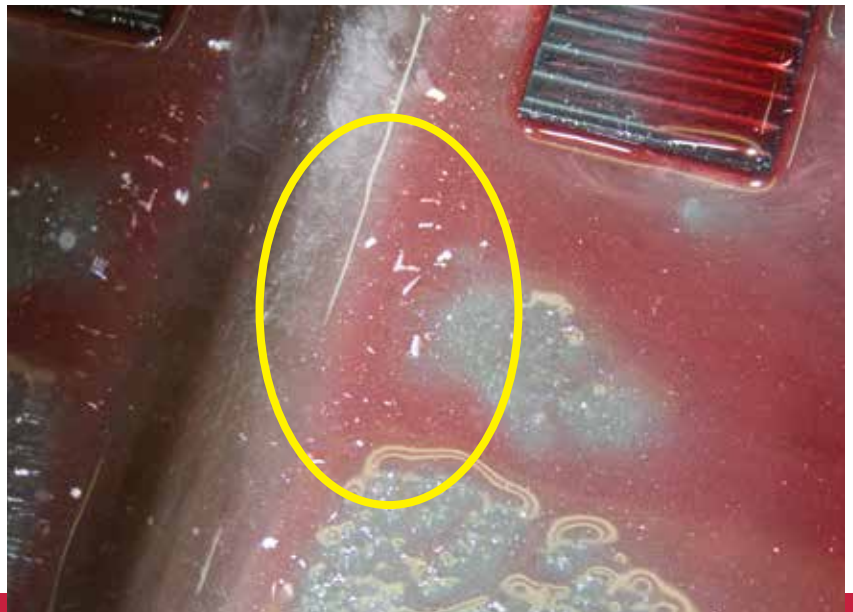
Looking at their oil pan, you can clearly see metal shavings that are beyond what is considered normal break-in wear for a remanufactured transmission. This unit is already destined for premature failure.

Debris in the unit can lead to shift quality issues, sticking valves and premature failure.

Our units are thoroughly cleaned as part of the ISO9001:2008 controlled process.

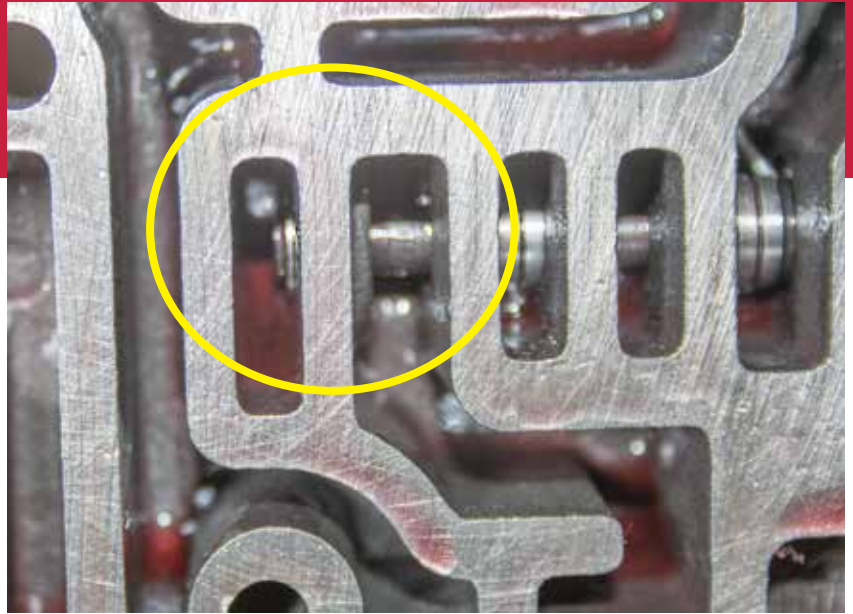
The valve in this body was sticking and the body had a burr which caused the valve to not move freely in the bore.

Sticky valves will lead to shift quality issues and performance problems.

Great care is taken on our units to remove all burrs and imperfections.

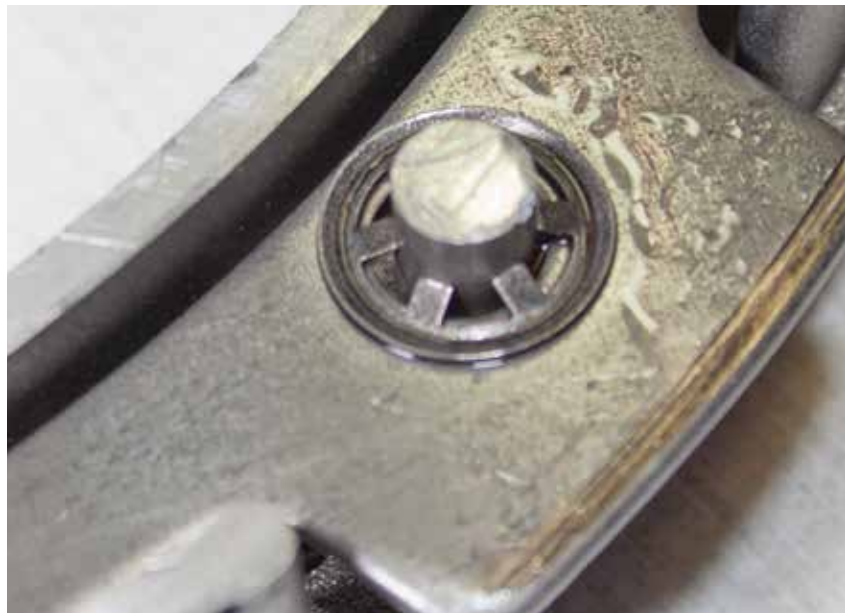
Note the retaining clips used in their transmission. These star clips are not per the Allison spec.

Note the Genuine Allison OE retaining clips used on our transmissions. Sub-par retaining clips have been known to break apart, leading to contamination within the units.

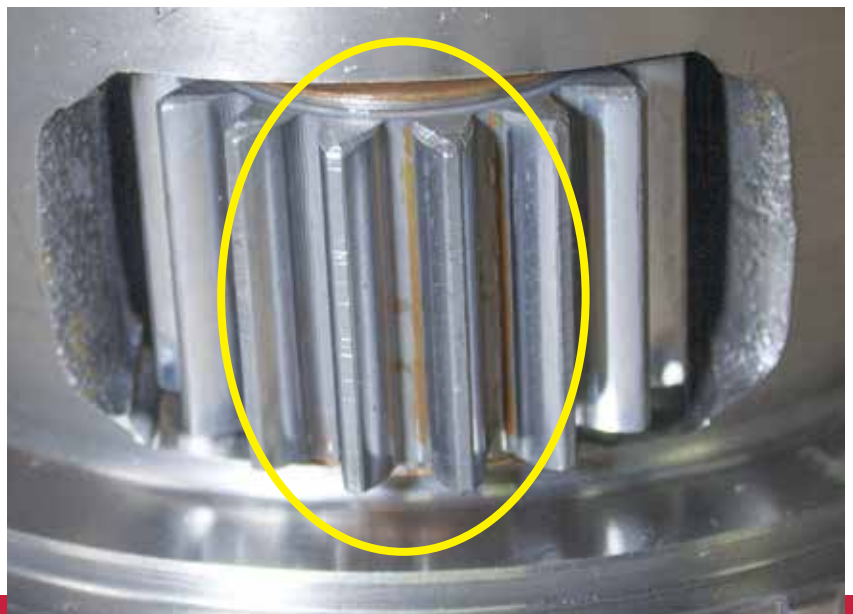
Their transmission included re-used rear carrier gears showing wear.

Also, only one gear on this unit was replaced.

Allison OE spec is that all four (the full set) should be replaced during a reman. This will minimize gear whine and excessive noise.

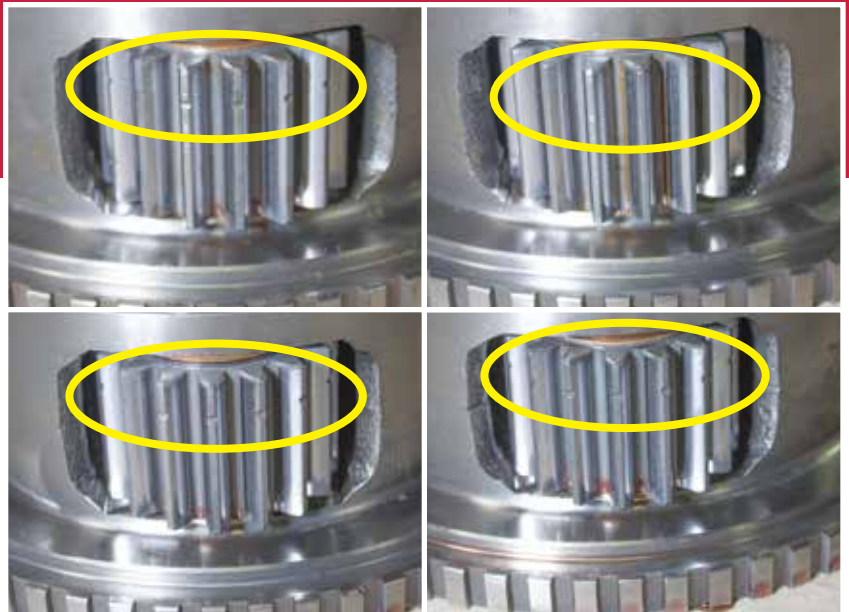
A closer look at all four gears shows that this is not a matched set. While the entire assembly may be salvaged as part of the reman process, these gears would not pass QC inspection at TRC.

**NOTE:** Notches are machined into each set of gears to identify them as a matched set. This is an unmatched set of gears.

An example of a salvaged rear carrier set of gears that has passed QC inspection.

Note that all four gears have the same "matched set" notches.

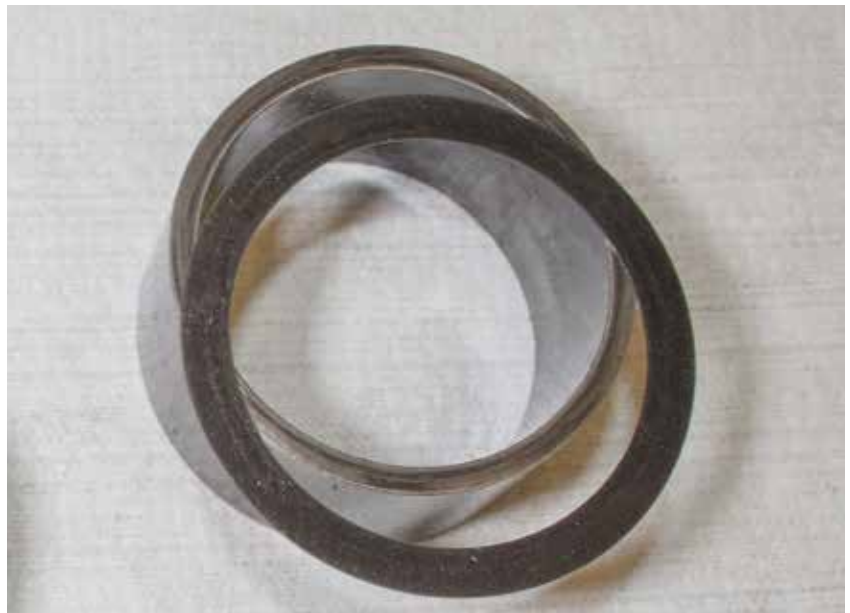
Their transmission rear carrier gear shaft has a shim ring added to compensate for wear instead of using an Allison-approved one-piece sleeve.

This is not an approved part or fix.

Shown here is the oversized sleeve that is approved per the Allison spec.

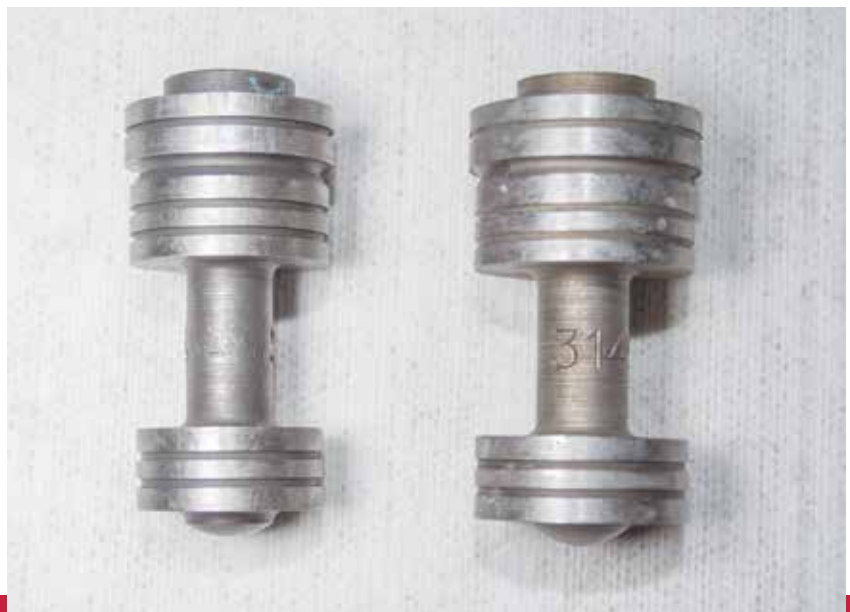
Shown here is one of the more unforgiving aspects of their transmission.

The transmission was ordered with a Reduced Modulator Calibration Kit (RMC) installed.

Upon review, you can see that the valves are regular spec and not the ones for the optional kit that were specified.

By not replacing a transmission with a “like-for-like” model, the user will notice shift-related deficiencies.

These are the valves that should have been installed with the RMC kit.

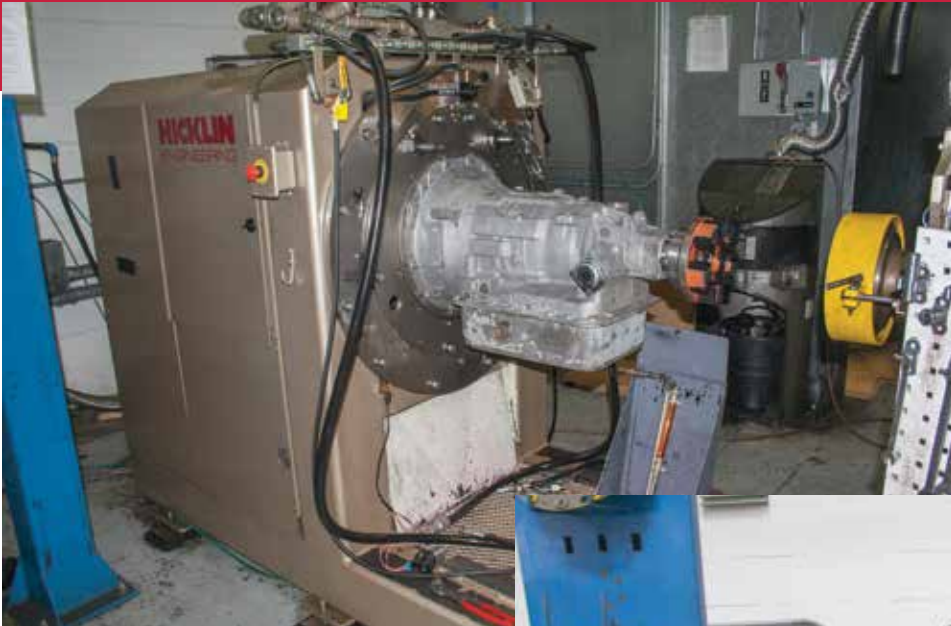
One of our Dynamometers in the process of testing an Allison transmission reman.
